ROYAL AIRCRAFT ESTABLISHMENT FARNBOROUGH (ENGLAND)

(9) Technical Report 78144

(6) TRIALS OF THE DOPPLER MICROWAVE
LANDING SYSTEM AT MANCHESTER
INTERNATIONAL AIRPORT,
OCTOBER/NOVEMBER 1977.

SUMMARY

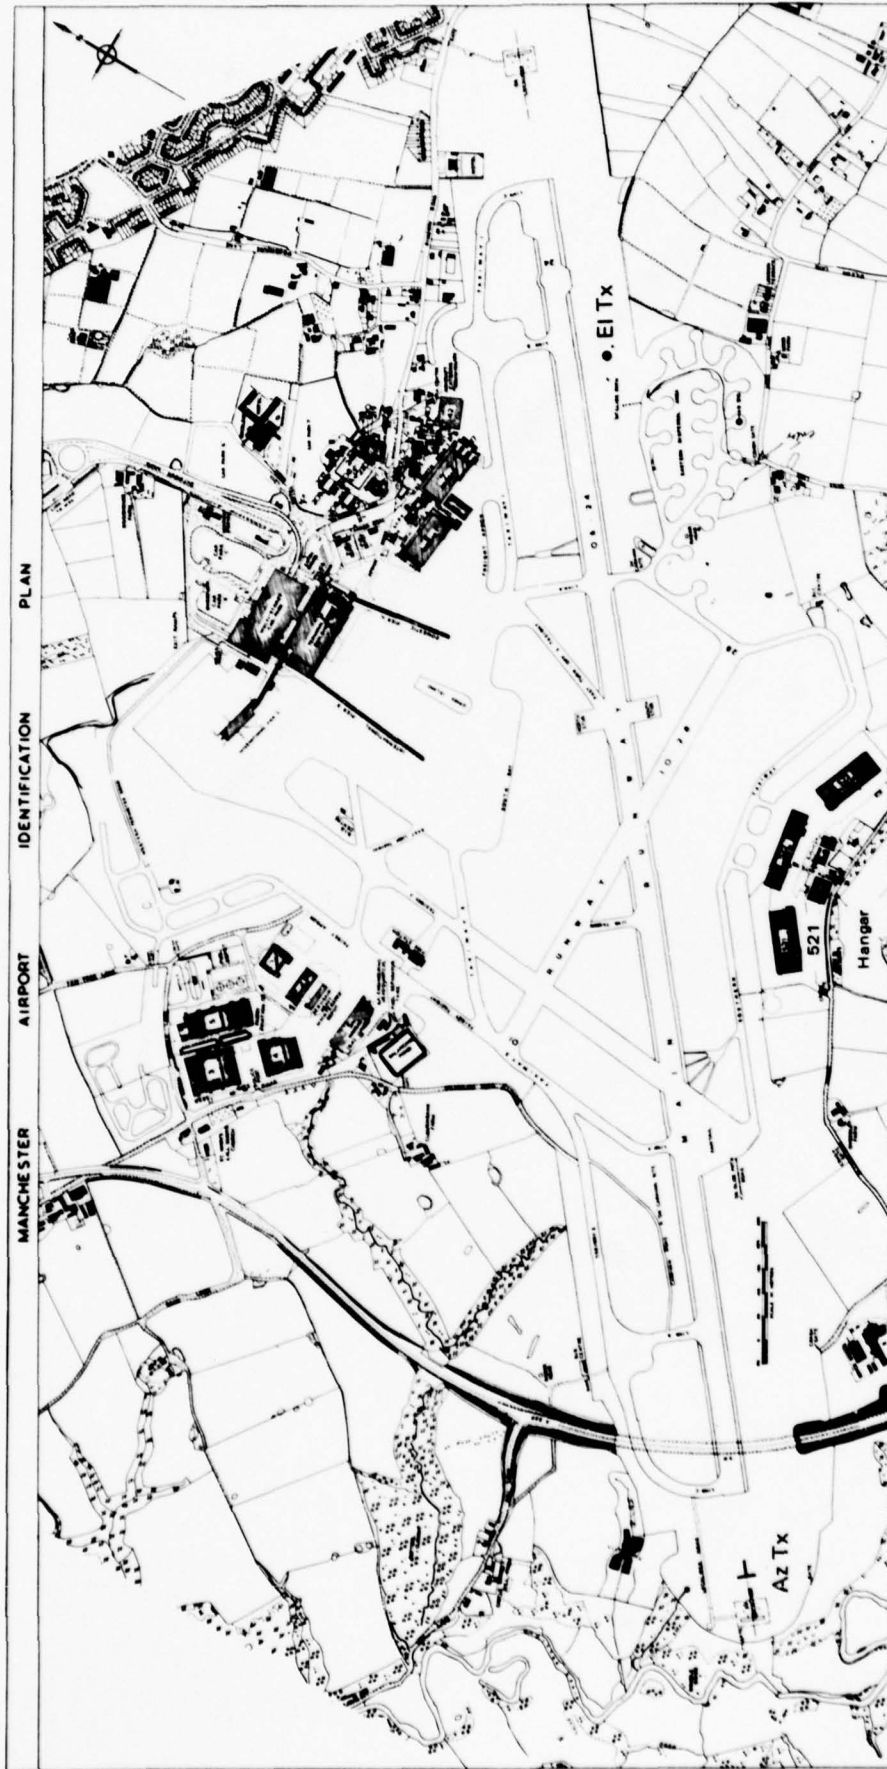
Fig 2 Manchester International Airport plan showing location of DMLS transmitters
